After six years: IKT researchers dig up their test stand for tree roots

After six years of growth: IKT researchers dig up their tree root test stand in Almere (Netherlands)

How to keep roots away from sewage pipes? IKT investigates protection systems in a long-term project. Researchers want to find out which protective measures are suitable. They have now dug up their worldwide unique in-situ test rig. The initial results are surprising.

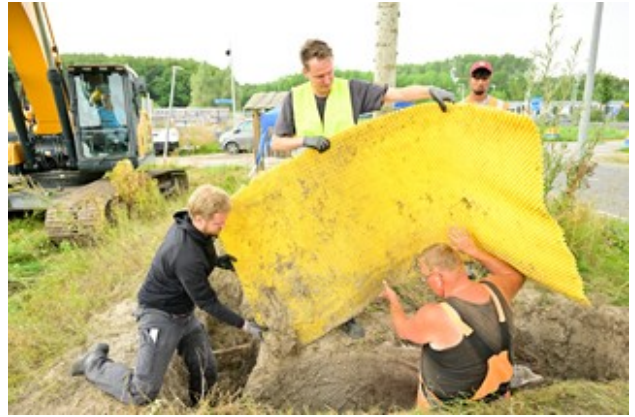
IKT researchers pull protective matting out of a sewer pipe trench that they installed six years ago to protect against root ingrowth.

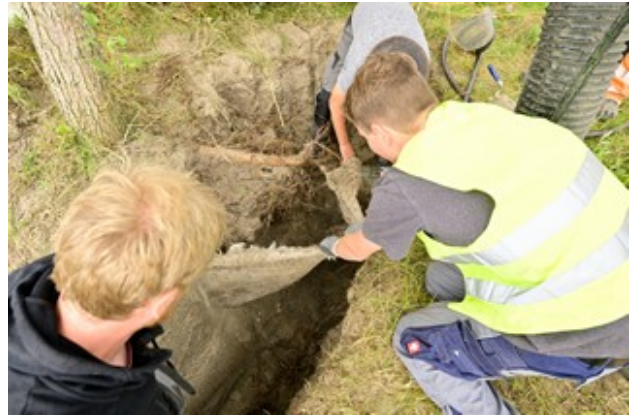
Root protection mat installed in the ground is removed.

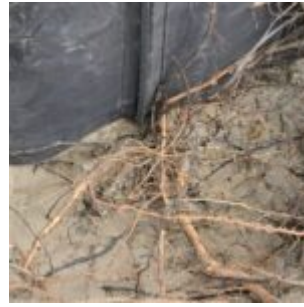
Protective mat to stop roots

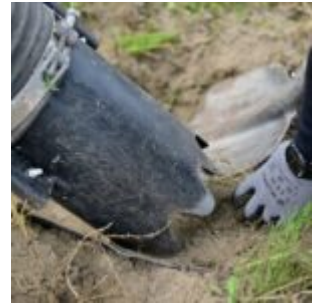
Tree roots are cleared with suction excavators, shovels and by hand.

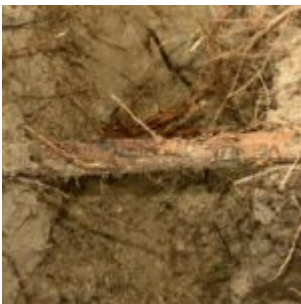
Horizontal root ingrowth in the pipe trench

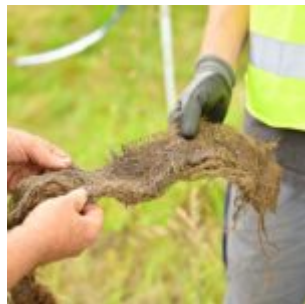
Root mats excavated from the IKT test stand

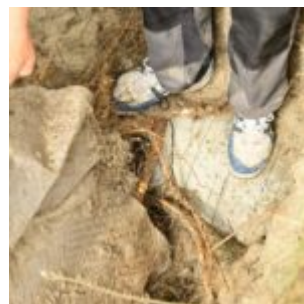
Protective mat, roots and sewage pipe

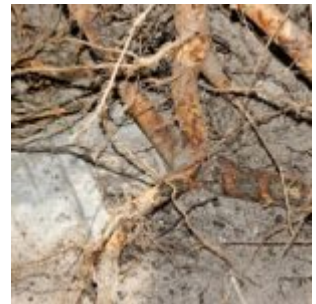
Almost like an ancient Roman trident: tree roots grow towards the sewage pipe

Visually alone, there was something unexpected: even thick roots branched out like an ancient Roman trident when they encountered resistance. They followed the relatively loose soil space around the sewage pipes. They looked for their way and found it. They bypassed the built-in obstacles – successfully at first glance.

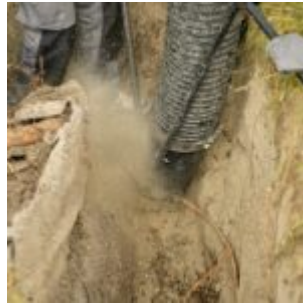
Suction excavator carefully removes soil around sewer pipes without damaging tree roots

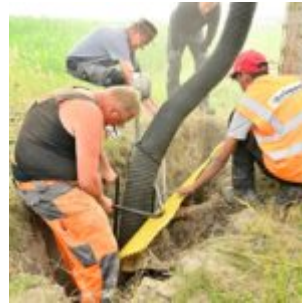
Roots and sewage pipes are excavated with great patience and sensitivity.
