After six years: IKT researchers dig up their test stand for tree roots

After six years of growth: IKT researchers dig up their tree root test stand in Almere (Netherlands)

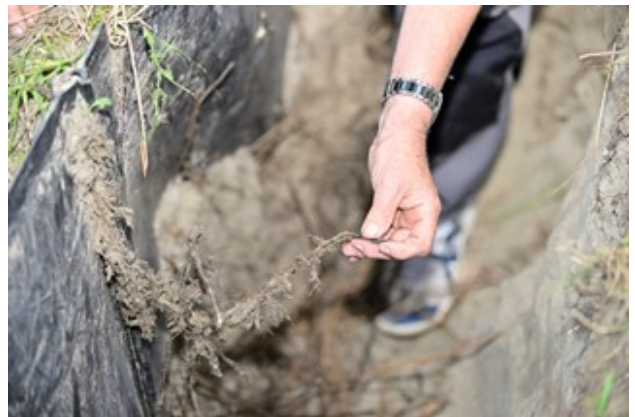
Despite protective mats: Roots continued to grow merrily

Some roots penetrated deeper into the earth along the vertical protective plates, only to grow upwards again behind the obstacle. Others bypassed the protection systems sideways. All of them grew towards the bedding zone of the pipes, probably because the soil is less compacted there and they can advance more easily than in the natural soil space.

Of the 15 pipe connections, 13 withstood the roots, two did not. The connections between the vertical protective plates were also not impenetrable in all cases. The roots snaked through here too.

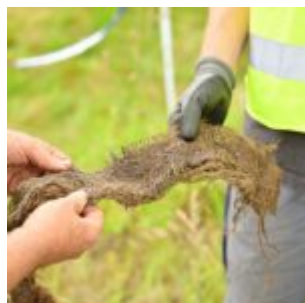
Root mats excavated from the IKT test stand

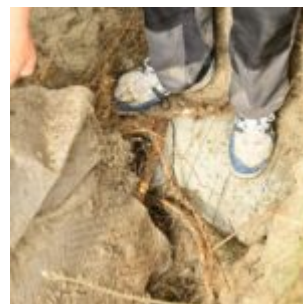
Protective mat, roots and sewage pipe

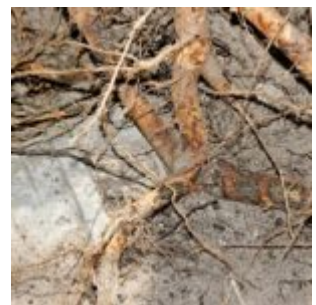
Almost like an ancient Roman trident: tree roots grow towards the sewage pipe

Visually alone, there was something unexpected: even thick roots branched out like an ancient Roman trident when they encountered resistance. They followed the relatively loose soil space around the sewage pipes. They looked for their way and found it. They bypassed the built-in obstacles – successfully at first glance.

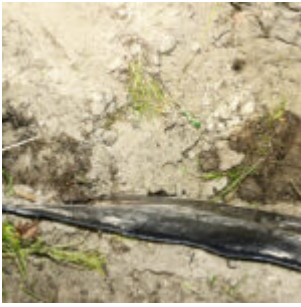
Looking vertically down into the pipe trench: The black protective mat against roots is clearly visible

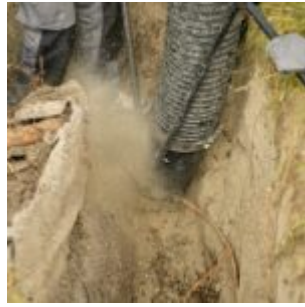
Suction excavator carefully removes soil around sewer pipes without damaging tree roots

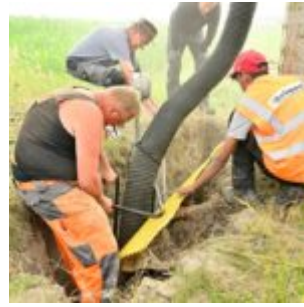
Roots and sewer pipes are excavated with great patience and sensitivity.
