IKT Compare: Can Short Liners Repair House Connections?

How do short liners perform? IKT figured it out in its latest IKT Compare project.

Short liners are often the first choice for **repairing local damage** in house connections. But, can they deal with **seriously damaged pipes**? The results of the new **IKT-Compare project "Short Liner for House Connections"** are now available.

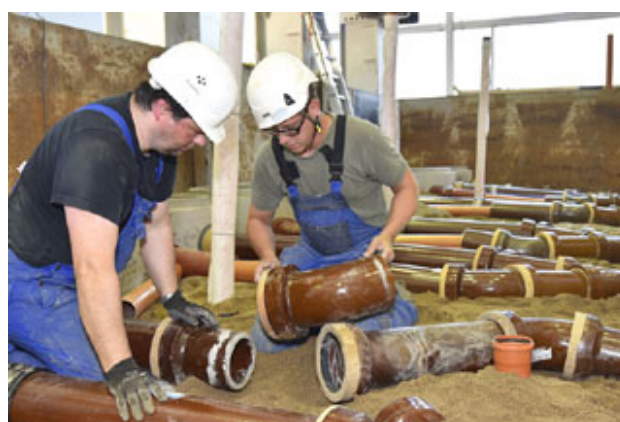
Deliberate defects: IKT has installed eight test sections with a total of 64 cases of damages in its large test pit.

length of sewer to which were attached one **house connection pipe** on the same level as the sewer pipe and two house connection pipes from a higher level. The house connection pipes were prepared with **defined areas of damage**, including milled patterns of **cracks**, the removal of some or all of the **joint seals** and **broken sections**. A total of **64 damage patterns** were produced – eight in each of the eight test rig setups.

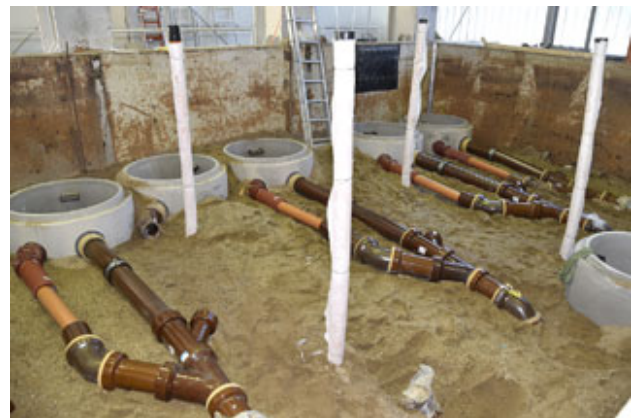
Repair objective: to seal damaged house connections.

In this IKT Compare project, the system suppliers demonstrated that **serious damage** to house connections can be **reliably sealed** using short liners, including breaks, cracks, misalignments and deflections. In particular, the **Twinbond** and **Trelleborg** systems proved to be the **most reliable** under permanent groundwater load, jetting, simulated backflow events and changing groundwater levels. For this they were deservedly awarded the **score of 1.0** for water tightness.

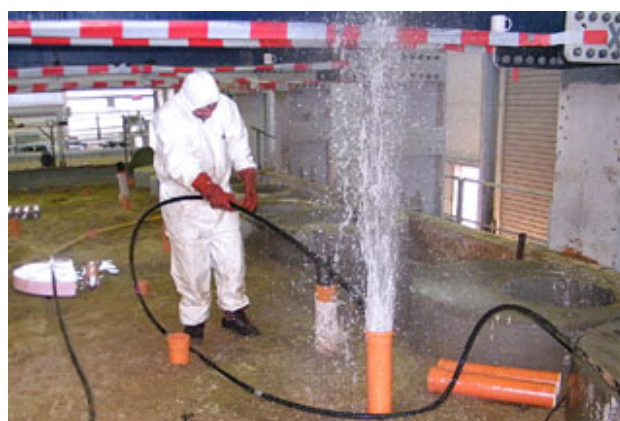
High-pressure jetting did not affect the short liners.

The test scenarios **simulating sewer operation**, such as high-pressure jetting, water backing-up in the pipe, and changing groundwater levels, had **no significant effects** on system performances.
