# IKT Compare: Can Short Liners Repair House Connections?

How do short liners perform? IKT figured it out in its latest IKT Compare project.

**Short liners** are often the first choice for **repairing local damage** in house connections. But, can they deal with **seriously damaged pipes**? The results of the new **IKT-Compare project "Short Liner for House Connections"** are now available.

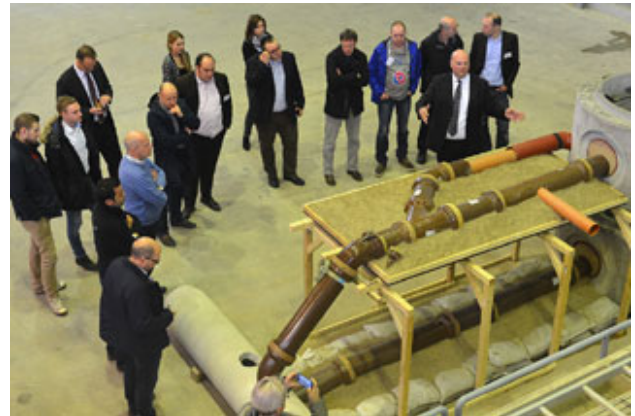
Two up, one down: the test set-up.

For this project IKT built eight identical **1:1 scale rigs**, in its large-scale test pit (15m by 6m by 6m), into which suppliers installed their short liners. Each rig comprised a

length of sewer to which were attached one **house connection pipe** on the same level as the sewer pipe and two house connection pipes from a higher level. The house connection pipes were prepared with **defined areas of damage**, including milled patterns of **cracks**, the removal of some or all of the **joint seals** and **broken sections**. A total of **64 damage patterns** were produced – eight in each of the eight test rig setups.

- **Test Setup I** (the lower house connection pipe, to which a 2m head of external groundwater was subsequently applied): cracks, a broken joint, a radially displaced joint and a joint displaced at an angle
- **Test Setup II** (the two higher house connection pipes, to which a 1m head of groundwater pressure was subsequently applied): a defective change of pipe material, defective change of pipe diameter and material from cast iron DN 150 to PVC DN 125, a defective change of pipe diameter and material from clay pipe DN 150 to PVC DN 125, and a break in the joint of a 45 degree bend

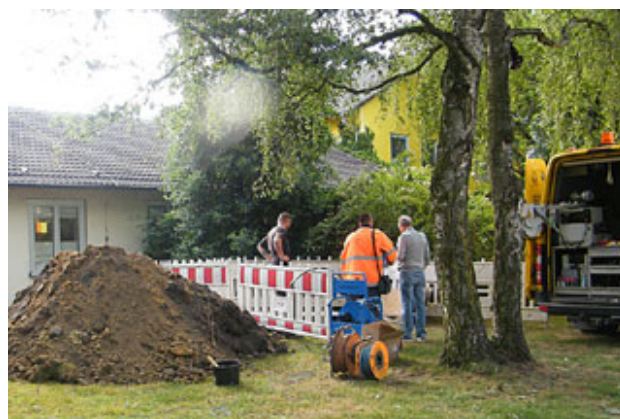
In-situ tests: lab tests were validated through in-situ observation of the same systems being installed at actual construction sites.

In addition to physical tests, the **QA/QC procedures** were examined. The laboratory results were validated through **in-situ observation** of the same systems being installed at actual construction sites. The **final scores** in this IKT Compare test are based on these three evaluations. The **range of grades** applied is from VERY GOOD (score of 1.0) to INSUFFICIENT (score of 6.0).

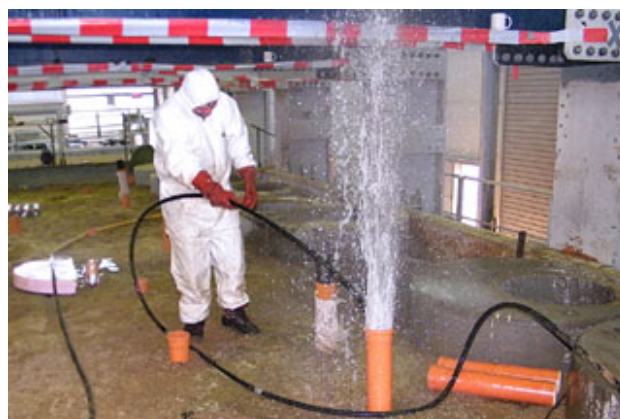
High-pressure jetting did not affect the short liners.

The test scenarios **simulating sewer operation**, such as high-pressure jetting, water backing-up in the pipe, and changing groundwater levels, had **no significant effects** on system performances.
