# **IKT-LinerReport 2017: CIPP Liner Quality – The Need to Pass all Four Tests**

**Too many liners still do not meet all four of the test criteria. They may pass individual criteria, but only those samples that pass all four can be considered really good.**

For the fourteenth year running, IKT - Institute for Underground Infrastructure is pleased to present its annual **LinerReport**. This sets out the results from over 2,100 liner samples taken from rehabilitation sites for **quality control** purposes in 2017 and tested by the **IKT CIPP Liner Test Centre**.

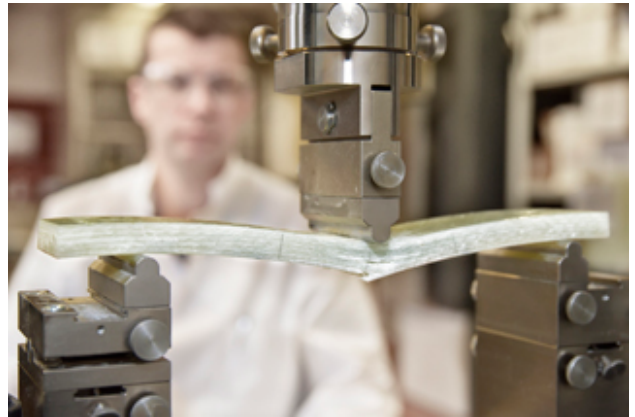
Under pressure: An IKT tester determines flexural strength at the point when a liner sample ruptures.

The flexural strength test results were similar to the Modulus of Elasticity, with the **average result lower** than in both

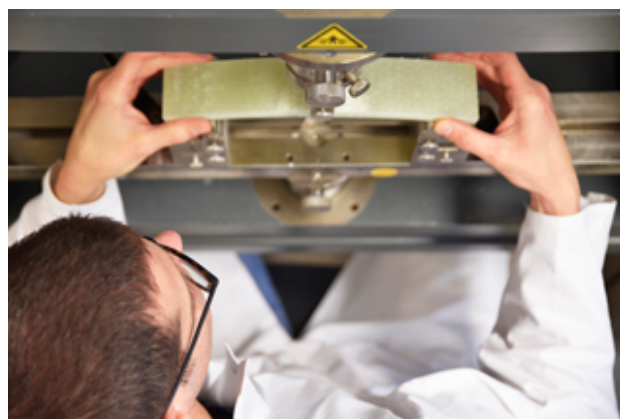
Modulus of elasticity and flexural strength: weaker results than for previous years

On average, **97.4%** of the liners reached their required modulus of elasticity. This result was **1.5% lower than 2016** and 1.7% lower than 2015, the year when the highest score was achieved in any of the previous IKT LinerReports. However, this does not necessarily indicate a trend. Fifteen out of the 25 rehabilitation companies in this year's survey achieved 100% for this test, one of them for two different liner systems.

previous years (-0.8% and -1.7%, respectively). Fourteen rehabilitation companies achieved a score of 100%, but the results were much more **broadly distributed**. The lowest-scoring company passed only 70% of the tests.

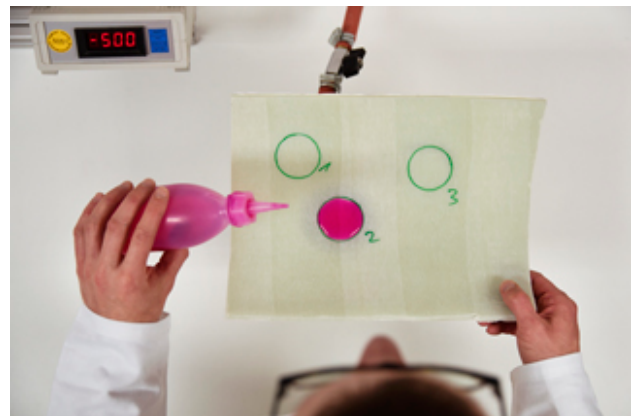
Under vacuum pressure: the test fluid leaked through the laminate in very few samples.

The water-tightness results remained at the same **high average level** as the previous year, with **99.1%** of samples passing. This was the highest average score of all four test criteria. Seventeen rehabilitation companies passed all of the water-tightness tests.

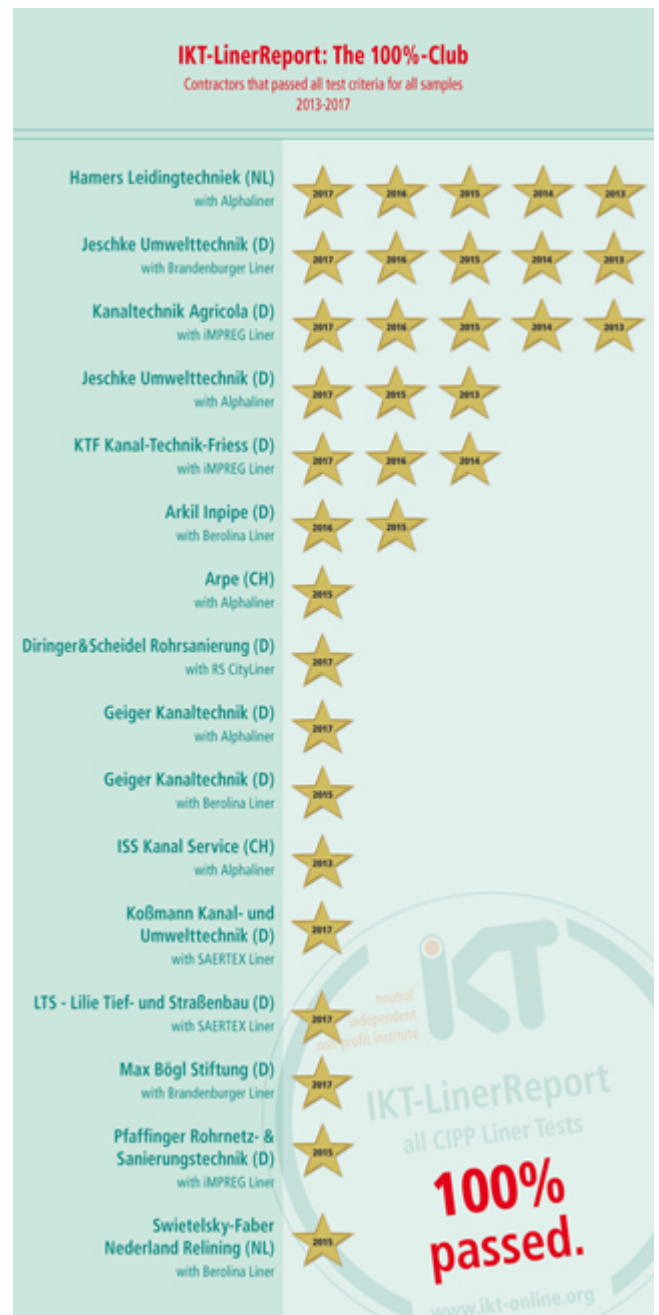
The proportion of the liner samples tested in 2017 that actually met **all four test criteria** was 63% (previous year: 61%; see Diagram 1). While it is good that this rate has slightly improved on last year, it must be noted that **more than one-third** of the liner samples **failed** to meet one or more test criteria. Thus they do not meet the standards for high-quality sewer rehabilitation.

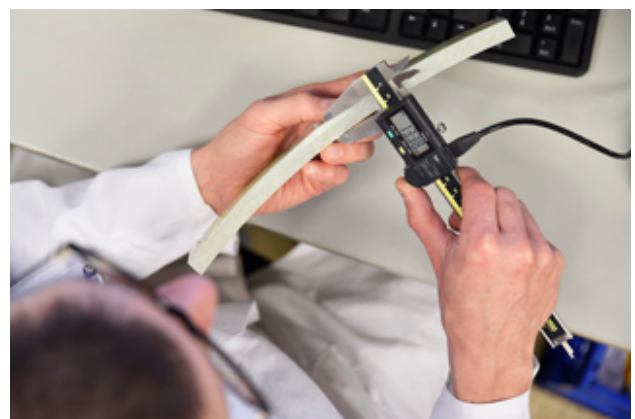
Wall thickness: wide distribution of results with lowest-scoring company passing only 60% of the tests

On average, the results of the wall thickness test were **lower** than for the two previous years: -1.7% compared to 2016 and -0.9% compared to 2015. The **distribution of results** for wall thickness was much greater than for the modulus of elasticity and flexural strength, with the lowest-scoring company passing 60% of the tests.

The goal of the material tests on liners is for a sample to **meet all four test criteria** – modulus of elasticity, flexural strength, wall thickness and watertightness. Only 63% of the 2,152 liner samples tested by IKT in 2017 met that goal, while **37% failed one or more tests**. The worst results were for wall thickness, which is especially important for structural stability.
